**Remediation of Motive Fuel Release Entering
Electrical Cooperative Building During Flood**
Location: Atlanta, Georgia
Client: Electrical Construction Company
Contract Cost: \$240,000+

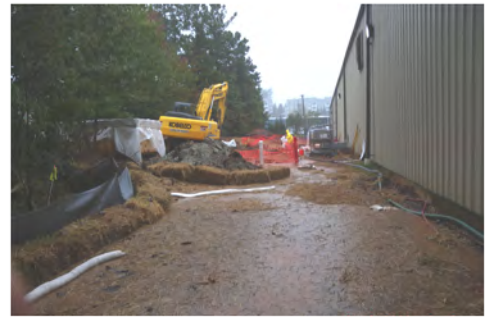
Fuel Follows Floodwater into Building

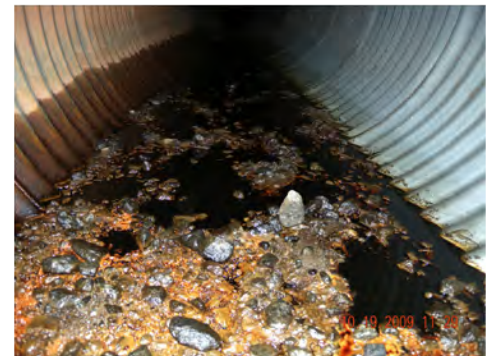
Culvert Draining Fuel from Contractor Facility

Over five-acres were investigated with ground penetrating radar and metal detection equipment to attempt to locate an underground storage tank. No point source was found. Additional test borings and 35 test pits (converted into multiphase extraction wells) traced the fuel foot print to an underground culvert and preferential pathways that flowed towards towards the Coop building. The source was determined to be releases from motive fueling of the contractors equipment over many years that had accumulated in a low spot that flood waters flushed out.

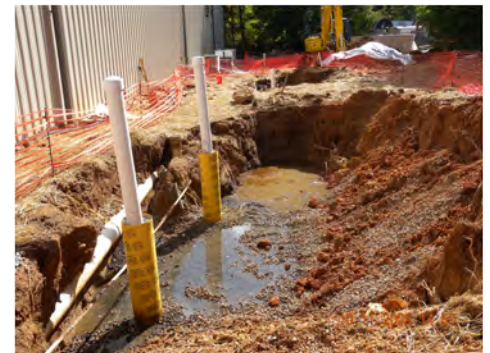
Interceptor Trench Installed Next to Building to Stop Fuel Infiltration

Remtech set up fuel recovery systems under the building and an interceptor trench with recovery wells to stop fuel from entering the building. Three containment/recovery points were also setup in the creek. Fuel was pumped into frac tanks and ventilation systems were set up to remove vapors from the building.

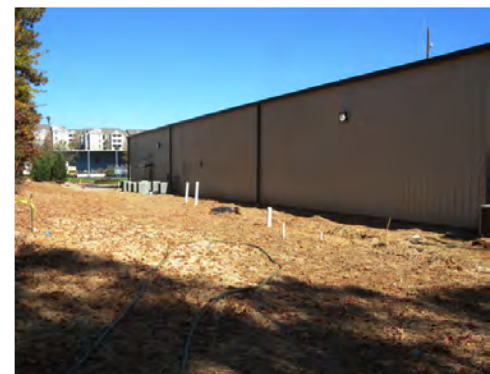
Completed Interceptor Trench with Recovery Wells
